Manhole Inspection Summary

Manhole # S35G__038MH

Insp Date: **11/24/08 2:48 PM**

Location Address: **1 n charles st**

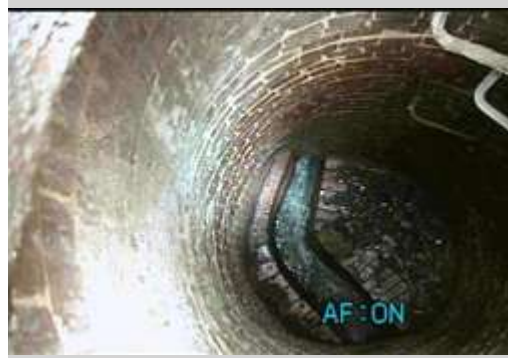
Top View

Comments **Couldnt get better pics due to steam**

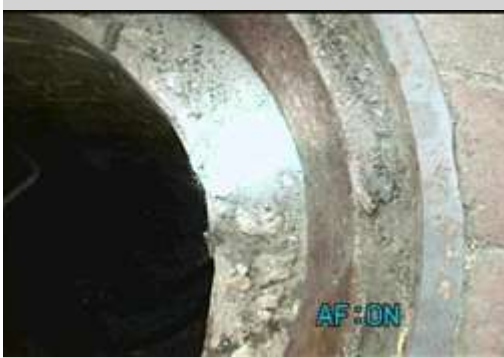
Defect 2

Frame Offset: **4** (in.) Condition: ☒ Sound ☐ Cracked ☐ Leaks

frame offset

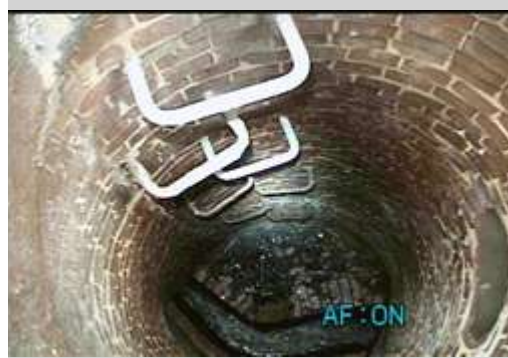
Defect 1

Steps Count: **7** Missing: **0** ☒ **Corroded**

corroded steps

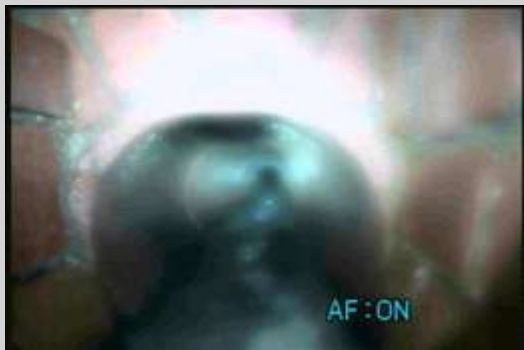
12 O'Clock Outflow

8 in. Circular Gravity Sewer
Pipe Out @ 12 OClock

Invert Depth: 12.50 (ft.) Flow Characteristics: Fast

Infiltration: None Pipe Seal Cond: Unknown

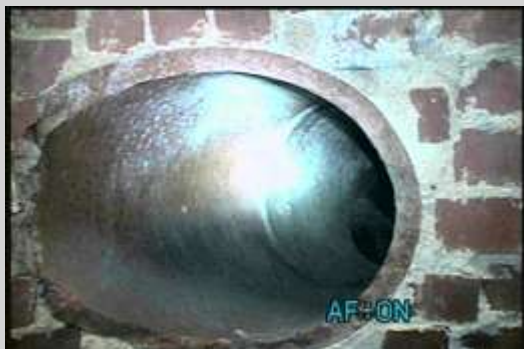
5 O'Clock Inflow

8 in. Circular Gravity Sewer
Pipe In @ 5 OClock

Drop In @ 5 OClock

Drop: Outside Direct

Drop Condition: Open
